Statistical Analysis & Numbers:  
Key Evaluation of Trends in Coal Mine Accidents

2016-2022

Government of India  
Ministry of Labour & Employment  
Directorate General of Mines Safety

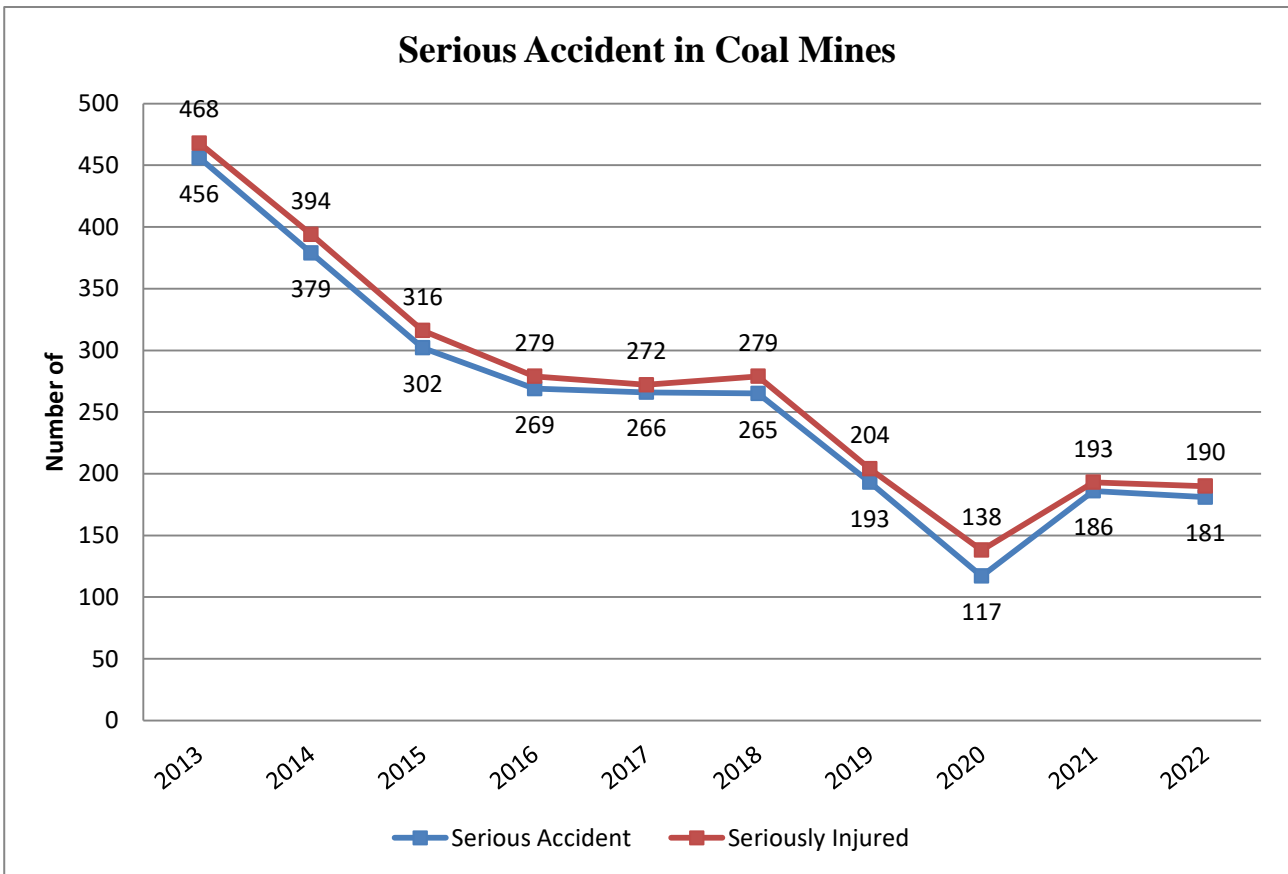
Figure 2.2

- The highest number of serious accidents as well as seriously injured persons occurred in 2013 with 456 serious accidents and 468 seriously injured persons.
- There's a general declining trend in both serious accidents and seriously injured cases
- 2020 had the lowest number of serious accidents and seriously injured cases.
- The decreasing trend in serious accidents and seriously injured cases suggests the effectiveness of safety measures over time. The lower numbers in recent years are promising, but attention should still be given to identify underlying causes for the fluctuations.
- The number of seriously injured persons per serious accident to assess the severity of the accidents is:

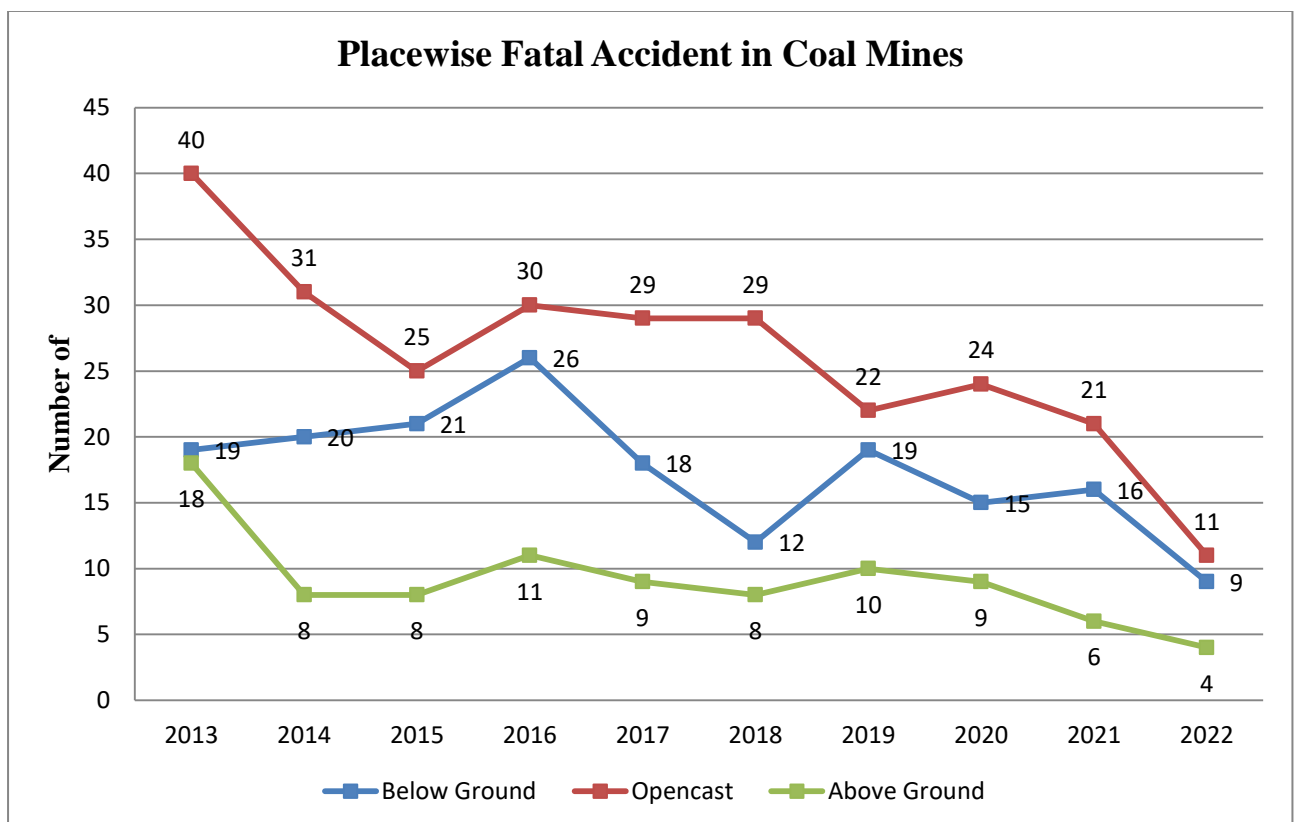
Figure 2.3

Place	Total Fatal Accident	Percentage
Below Ground	175	33%
Opencast	262	50%
Above Ground	91	17%

- The analysis of accidents by location within coal mines from 2013 to 2022 highlights that opencast mining experiences the highest number of accidents, followed by Below Ground and Above Ground. Strengthening safety measures in opencast mining and maintaining vigilance in Below Ground mining are essential for overall mine safety.

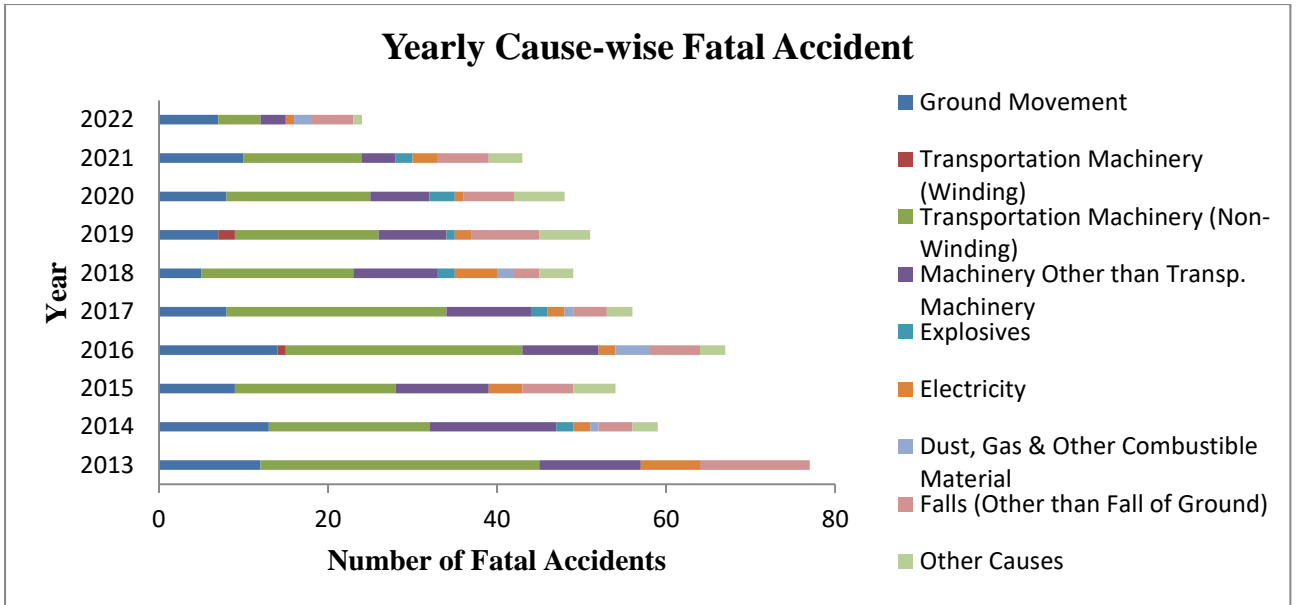
**Figure 2.5**

- "Transportation Machinery (Non- Winding)" caused the highest number of fatal accidents.
- "Ground Movement" and "Machinery other than Transportation Machinery" also contributed significantly to fatal accidents. The number of fatal accidents due to "Transportation Machinery (Winding)" has been relatively low.
- Accidents caused by "Explosives," "Electricity," "Gas, Dust & Other Combustible Material," "Fall (Other than Falls of Ground)," and "Other Causes" vary across the years.

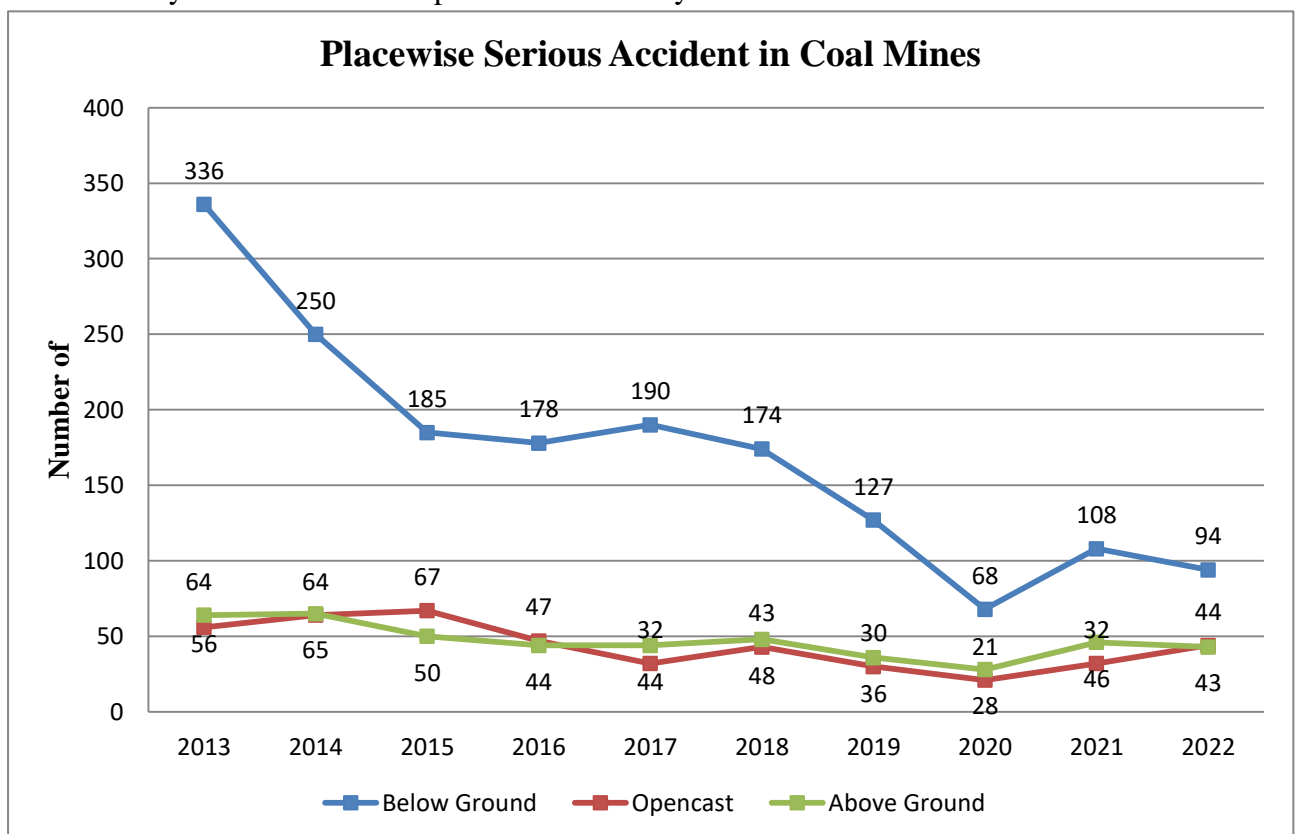
**Figure 2.7**

Place	Total Fatal Accident	Percentage
Below Ground	1710	65%
Opencast	436	17%
Above Ground	468	18%

- The exploratory analysis of serious accidents in coal mines based on different locations from 2013 to 2022 provides insights into the distribution, trends, and fluctuations in accidents. Identifying location-specific patterns and trends can guide safety interventions to improve worker safety and reduce serious accidents.

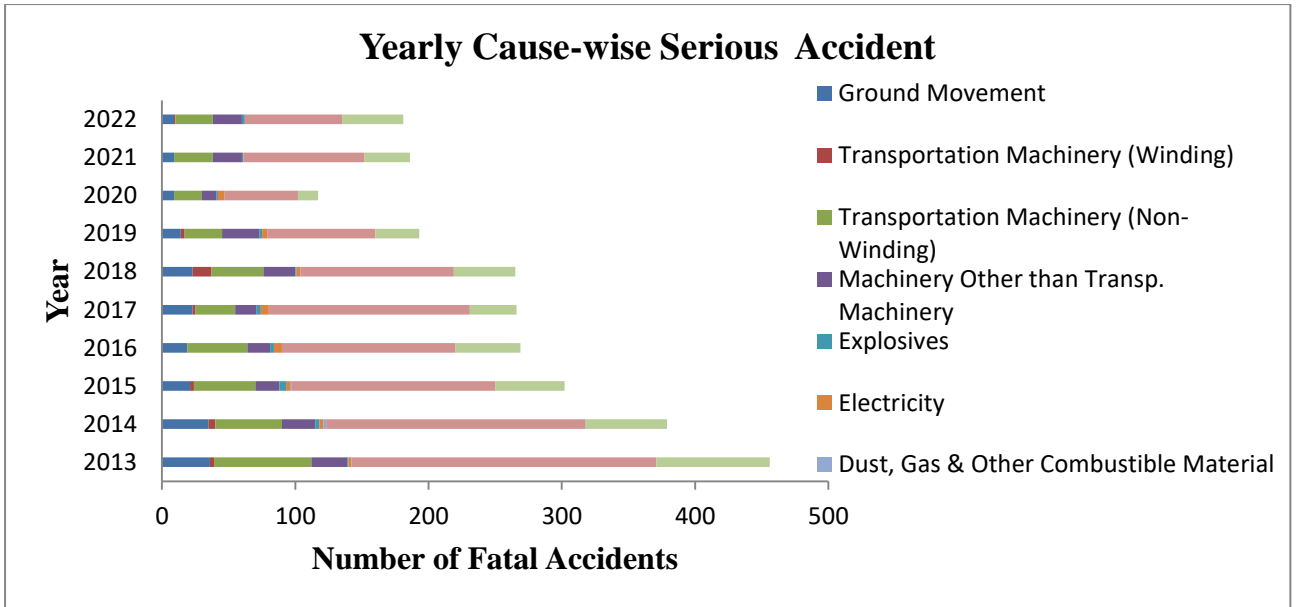
**Figure 2.9**

- “Fall (Other than Falls of Ground)” is consistently the leading cause of serious accidents, accounting for a significant portion of total accidents.
- "Transportation Machinery (Non-Winding)", "Other Causes" and “Ground Movement” are also notable contributors to serious accidents.
- The number of fatal accidents due to "Explosives", "Electricity”, “Gas, Dust & Other Combustible Material" and “Transport Machinery (Winding)” has been relatively low.
